Mount Mansfield Union High School to Jericho Center Multimodal Connection

In the Town of Jericho, Vermont

March 21, 2011 **DRAFT**

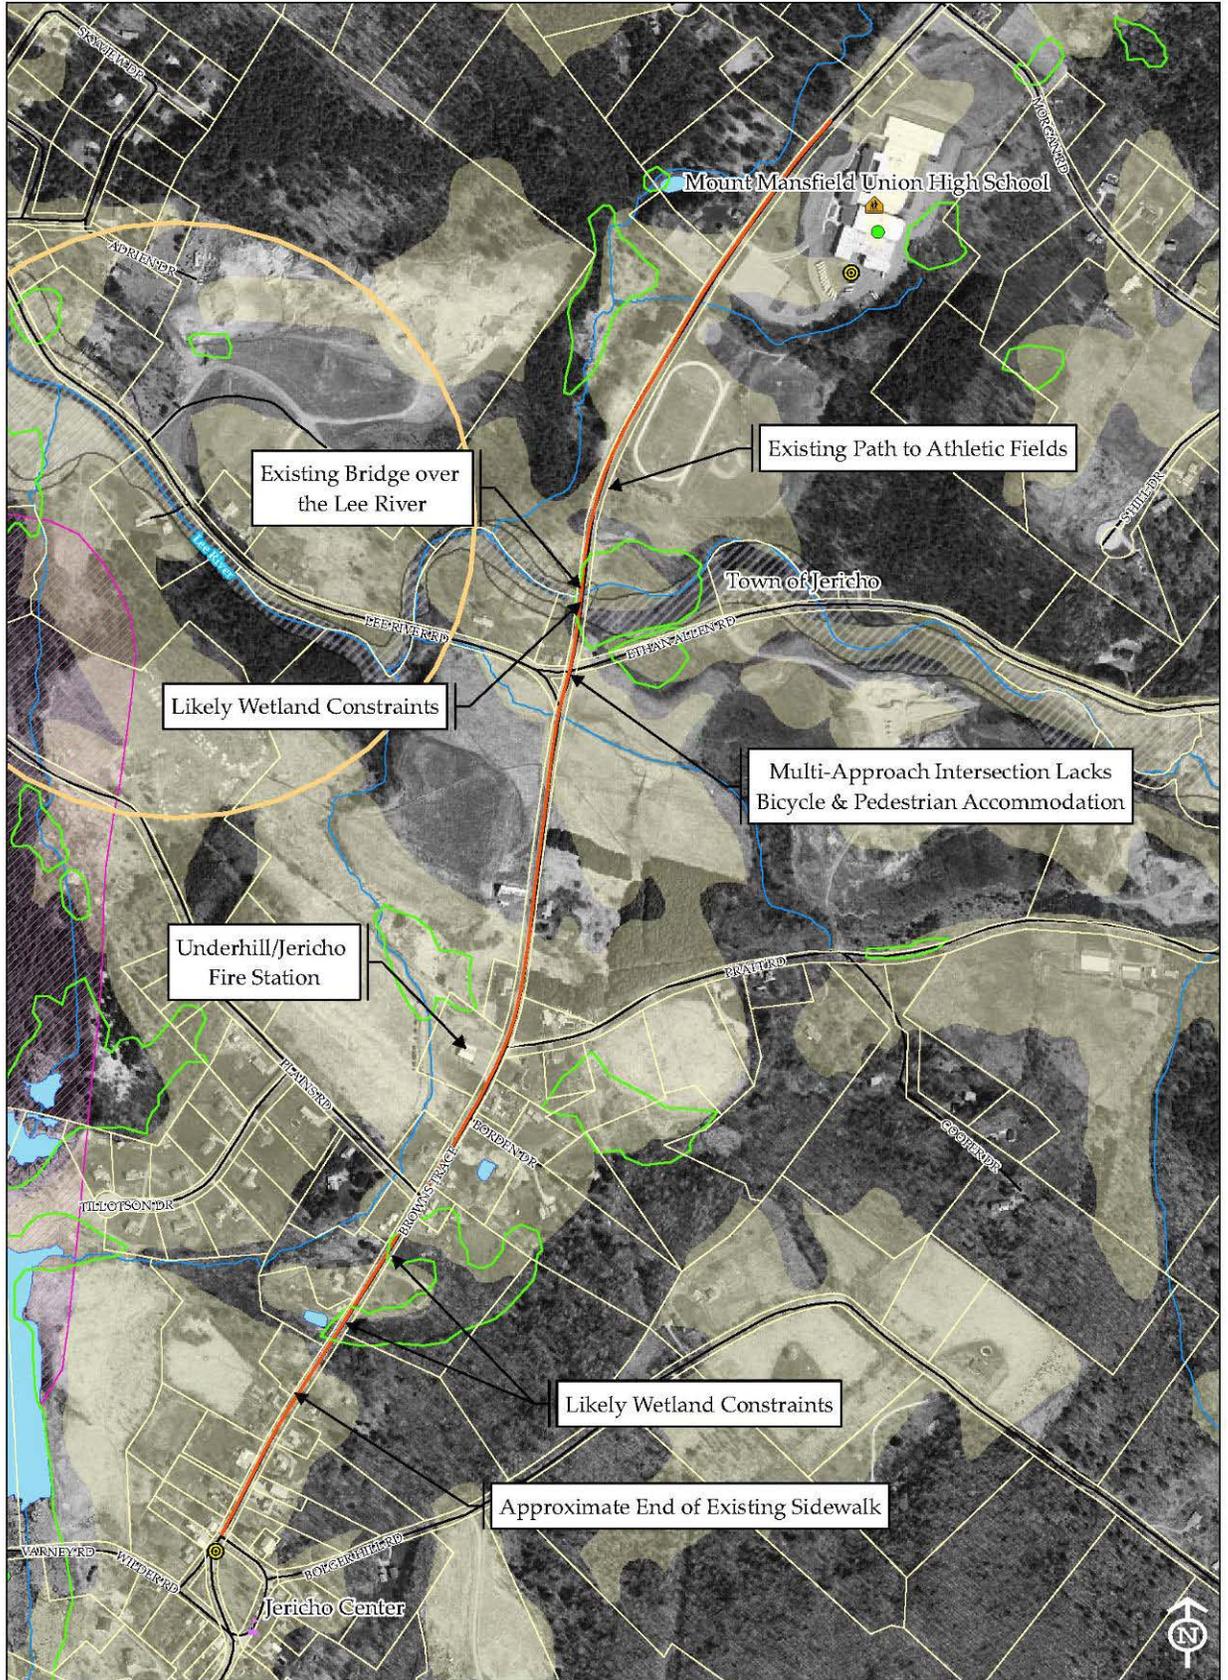
This multimodal study is a natural follow-on to the road safety audit since it addresses the safety and mobility needs of non-motorized users within the Browns Trace Road corridor. It is funded through a CCMPO Transportation Action Grant and it is intended to identify and evaluate potential bike and pedestrian infrastructure improvements. The map on the next page shows the study corridor.

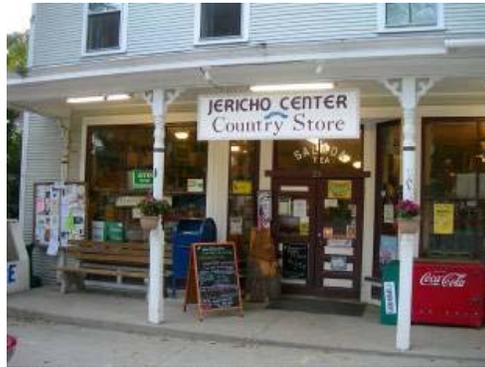
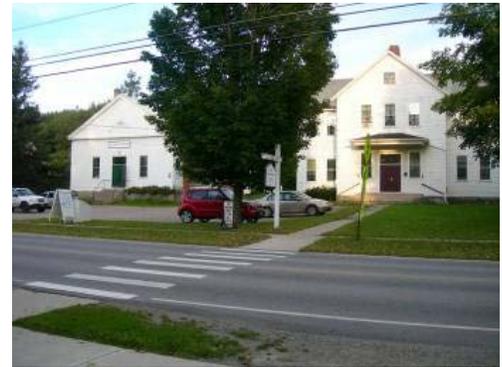
In recent years the Town extended sidewalks on Browns Trace a short distance northward of Jericho Center and these sidewalks connect a number of the local walking destinations, such as the Country Store, the Library, the Community Center and the Congregational Church. In speaking with local residents it appears that the existing sidewalks have been very well received.

The new concrete sidewalk on the west side of Browns Trace Road ends abruptly just north of the residence shown in the photo below.

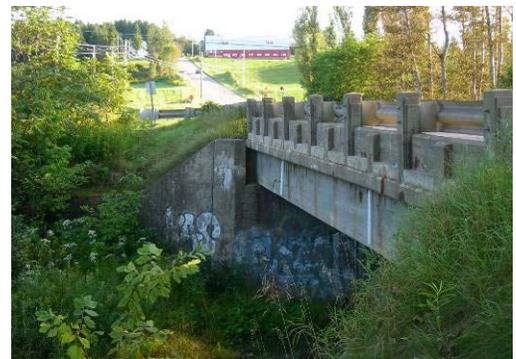
The first constraint is the existing Browns Trace roadway bridge over the Lee River, as shown in the photo. The existing bridge does not have sidewalks and the road does not have shoulders. Furthermore, the bridge's railings are too low to be considered safe for bicyclists or pedestrians. Bicyclists and pedestrians are therefore forced to share the road with motorists if they want to go south of the Lee River towards the Town Center.

The southeast quadrant bridge approach visible in this photo was the location where the VTrans archeologist suspects there was a blacksmith shop, so a pedestrian bridge

crossing in this area would need to skirt that site once the site boundaries are better documented.

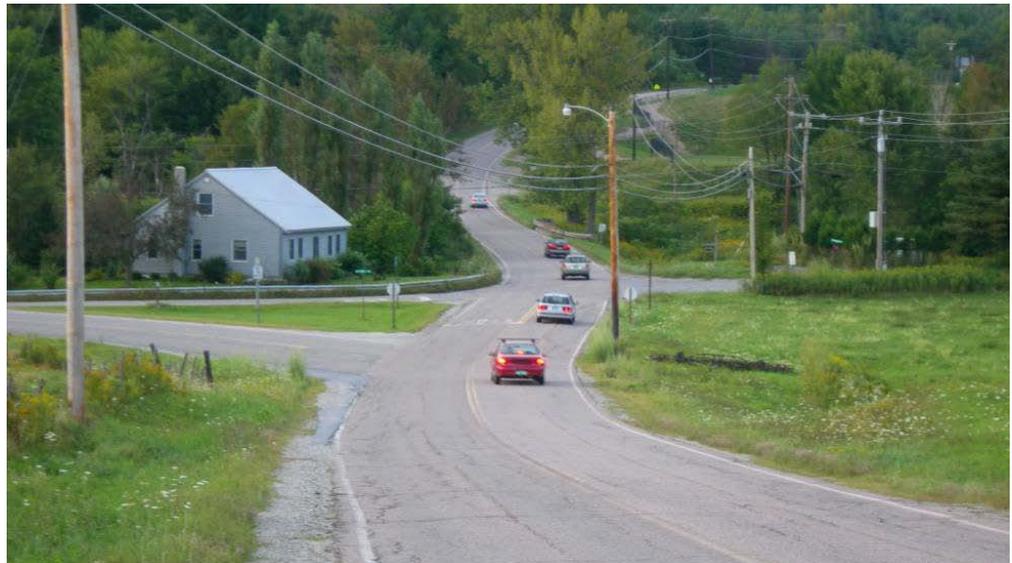
The next constraint is the Browns Trace Road/ Lee River Road/ Ethan Allen Road intersection, as shown below. Three legs of this intersection are under stop sign control, but the northbound approach is uncontrolled and the eastbound approach has a free right slip ramp configuration. This intersection was reviewed during the VTrans 2008 Road Safety Audit Review. The conclusion was that the configuration is a little odd because the heaviest through movement is stop controlled. The study noted that a long term solution might be to reconfigure the intersection to be a more standard 90 degree intersection.

The implications for a shared use path are that the path would need to be integrated safely into the existing and any future intersections. We are of the understanding that University of Vermont engineering students are currently examining a roundabout solution for this intersection. That alternative may provide better integration possibilities for the path.

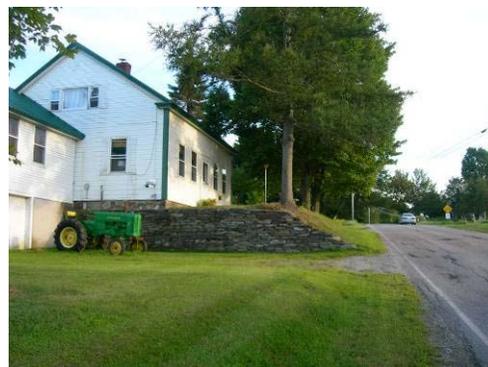
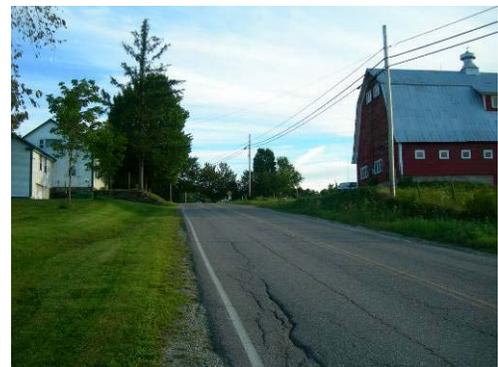
The barn and opposite farm house represent one of the more significant constraints on the project. The road at that location is only 25 feet wide and both structures are historically significant. The mature trees are also considered contributing to the historic setting and should not be impacted.

Fitting a shared use path through this constriction will be challenging. It may be necessary to actually shift the road and construct low fieldstone masonry retaining walls to manage the grading through this section. The path width may also need to be reduced to 8 feet or even less due to the extreme circumstances.

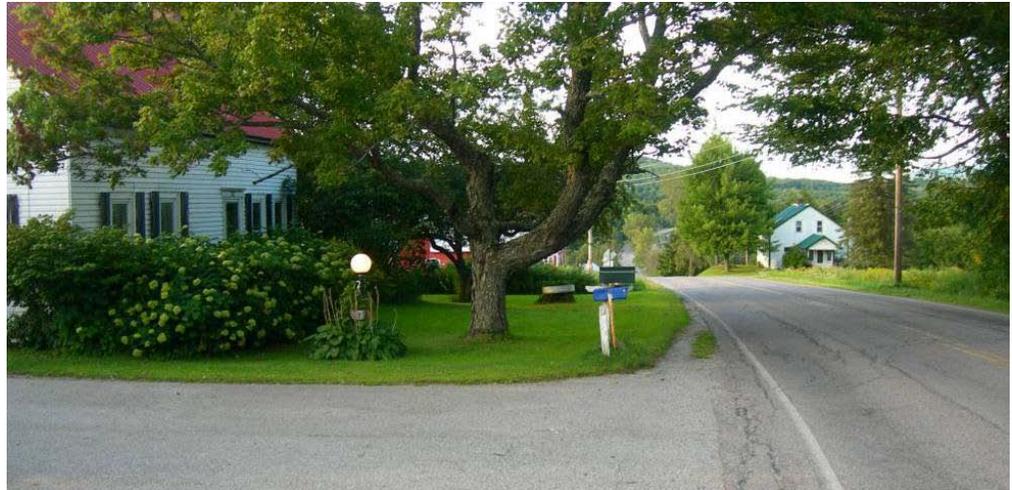
South of the farm buildings is another constriction. This next location is a historic home with a mature tree that appears to be overhanging into the right-of-way, as shown in the below photo. If a shared use path is located on the west side of the road, the roadway may need to be realigned in order to allow the tree to remain. That would require relocation of the utility poles on the opposite side of the road.

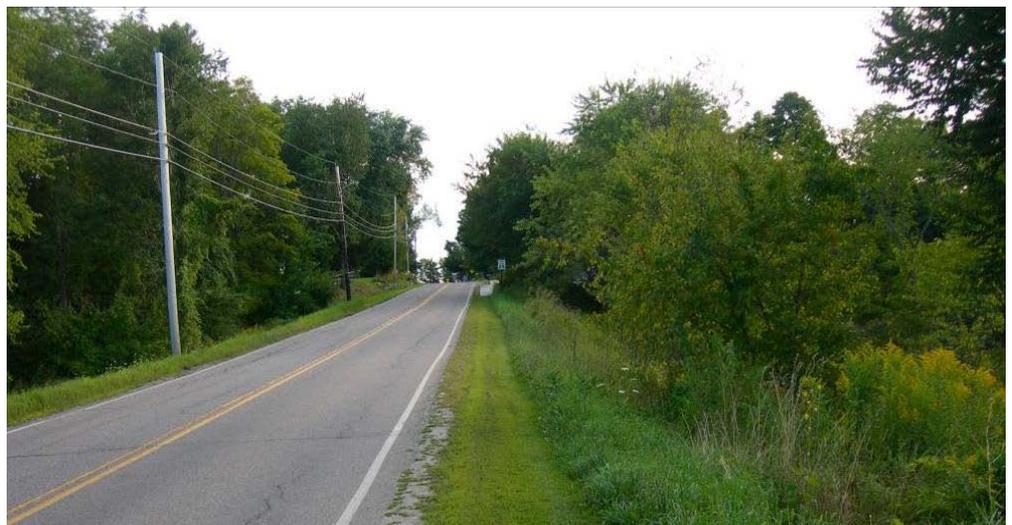
The next areas of concern that are south of the above property are wetland areas that come close to the roadway. The below south facing photo shows a wetland on the west side of Browns Trace Road and utility poles on the east side. Note the beginning of the concrete sidewalk on the west side in the distance. The attached wetland mapping shows the approximate locations where wetlands must be dealt with if a shared use path is proposed.

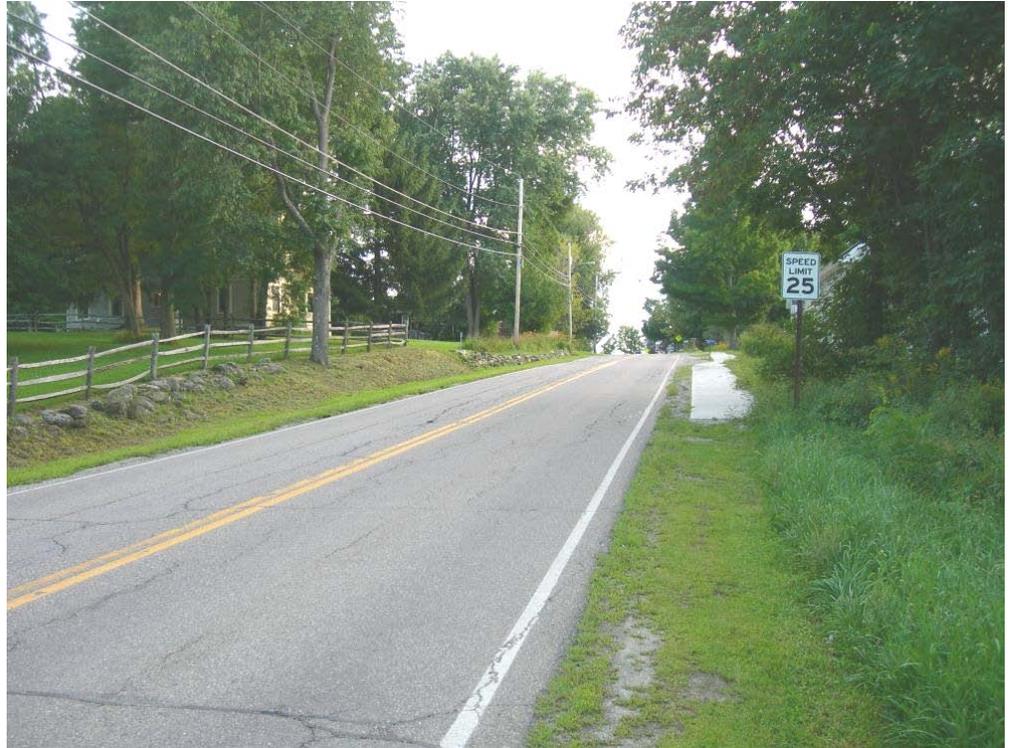
Selecting the location to end a shared use path is also important. The below south facing photo shows additional constraints closer to the Town Center. These include the stone walls, fences and mature trees that line the eastern right-of-way boundary.

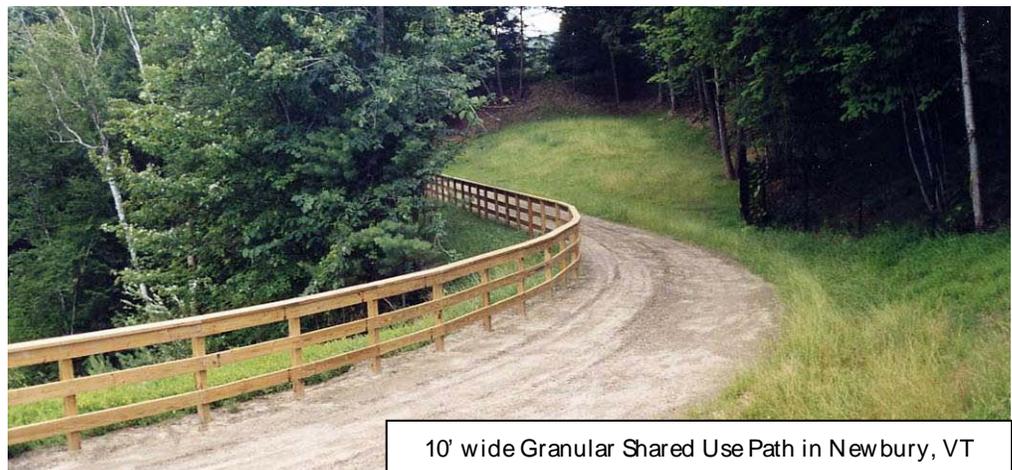
This alternative involves constructing an un-paved shared use path between the Town Center and the MMU High School. The width would be 8 feet in constrained areas and 10 feet elsewhere. The minimum vegetated buffer between the path and Browns Trace Road would be 3 feet. Additional buffer would be included where possible.

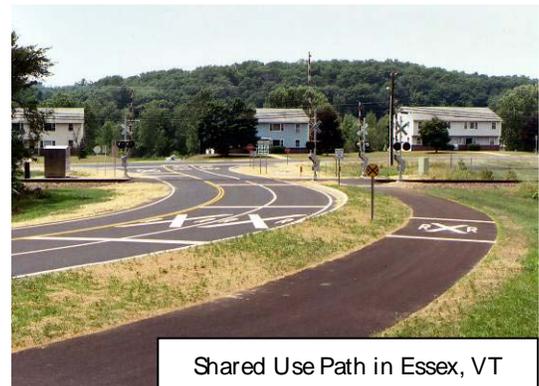
This alternative involves constructing a paved shared use path between the Town Center and the MMU High School. The width would be 8 feet in constrained areas and 10 feet elsewhere. The minimum vegetated buffer between the path and Browns Trace Road would be 3 feet. Additional buffer would be included where possible.

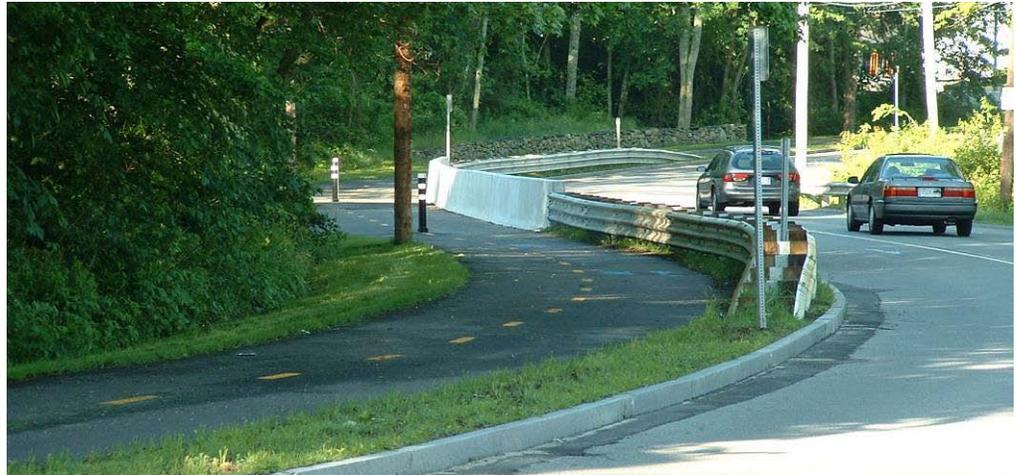
3.3 Shared Use Path Alternatives

It is evident from the discussions in the above previous section that the shared use path alternatives provide the highest level of improvement and satisfy the project Purpose and Need to the greatest extent. It is also clear from the discussion of constraints in Section 2.3 that it will be difficult to construct a shared use path from the school all the way to the Town Center. A segment by segment evaluation of shared use path solution alternatives follows, beginning at the MMU High School.

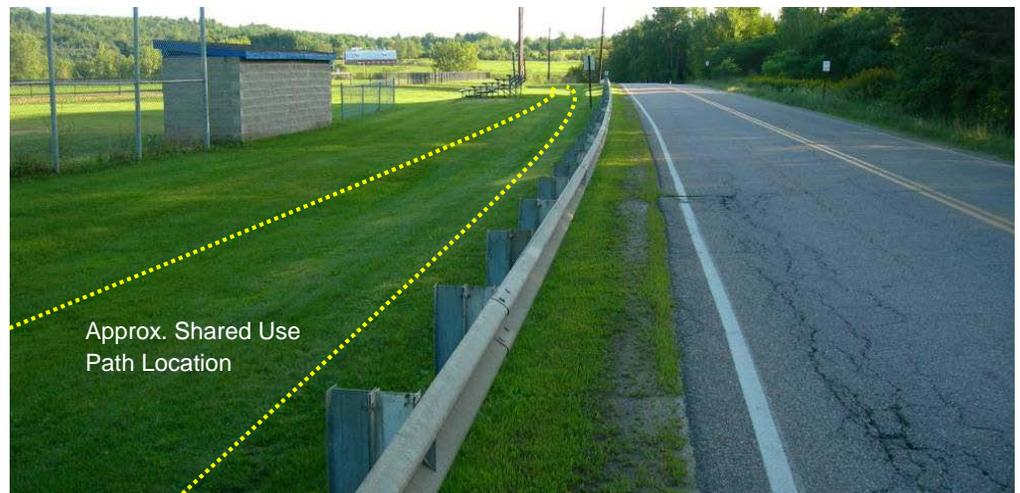
The path would originate at the school parking lot and proceed southward behind the existing guardrail as illustrated in the above photo. Within the school parking lot signs and pavement markings would be used to help define a preferred path and to alert motorists. Bike racks should be added at the school and/ or at the trailhead.

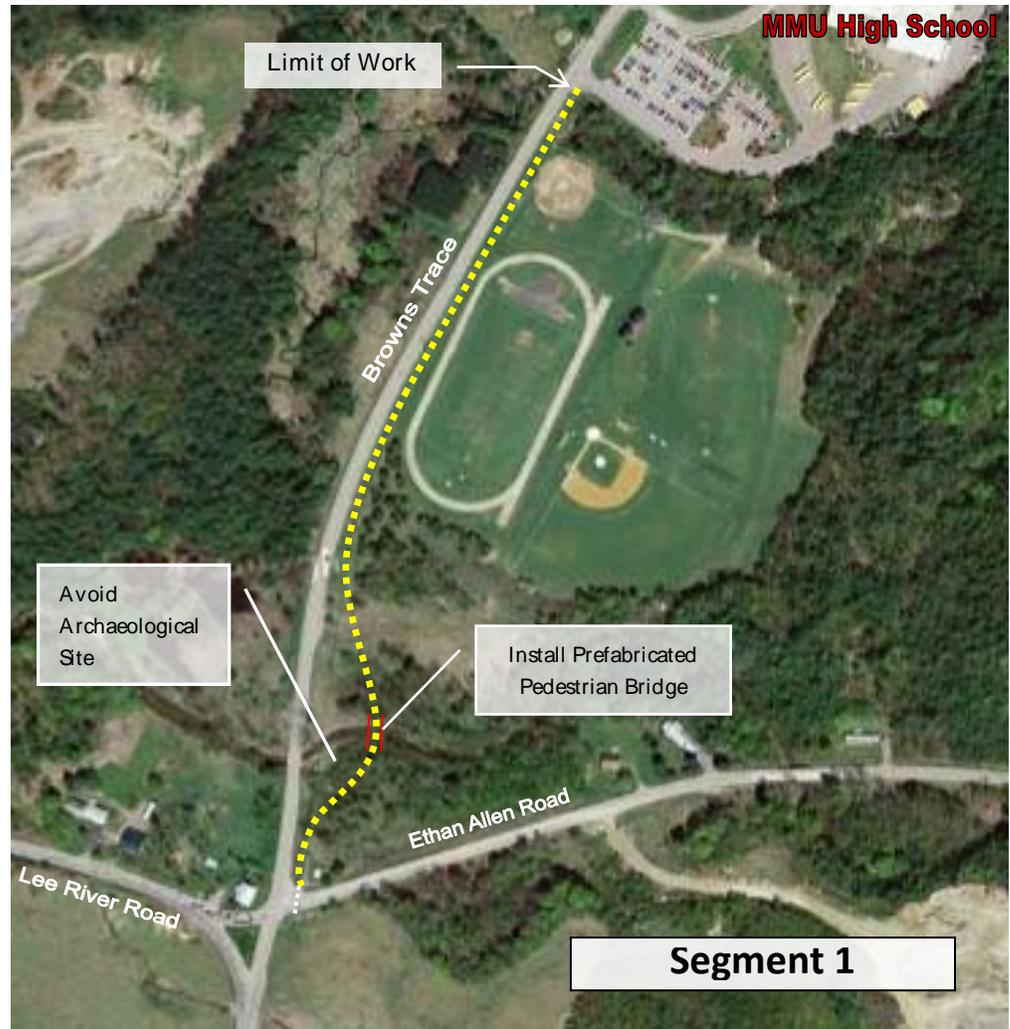
The path would follow the short existing path that leads from the recreations fields to Browns Trace Road. It would then diverge away from the road to cross the river on a new prefabricated bike/ pedestrian bridge. The new bridge would have a span longer than the roadway bridge to minimize impacts to the stream bank. The path alignment would be adjusted to avoid the reported remnants of a blacksmith shop building foundation that the VTrans archaeologist reported near the southeast corner of the existing roadway bridge.

Assuming the intersection configuration does not change, the path would cross Ethan Allen Road via a crosswalk at the stop sign controlled approach.

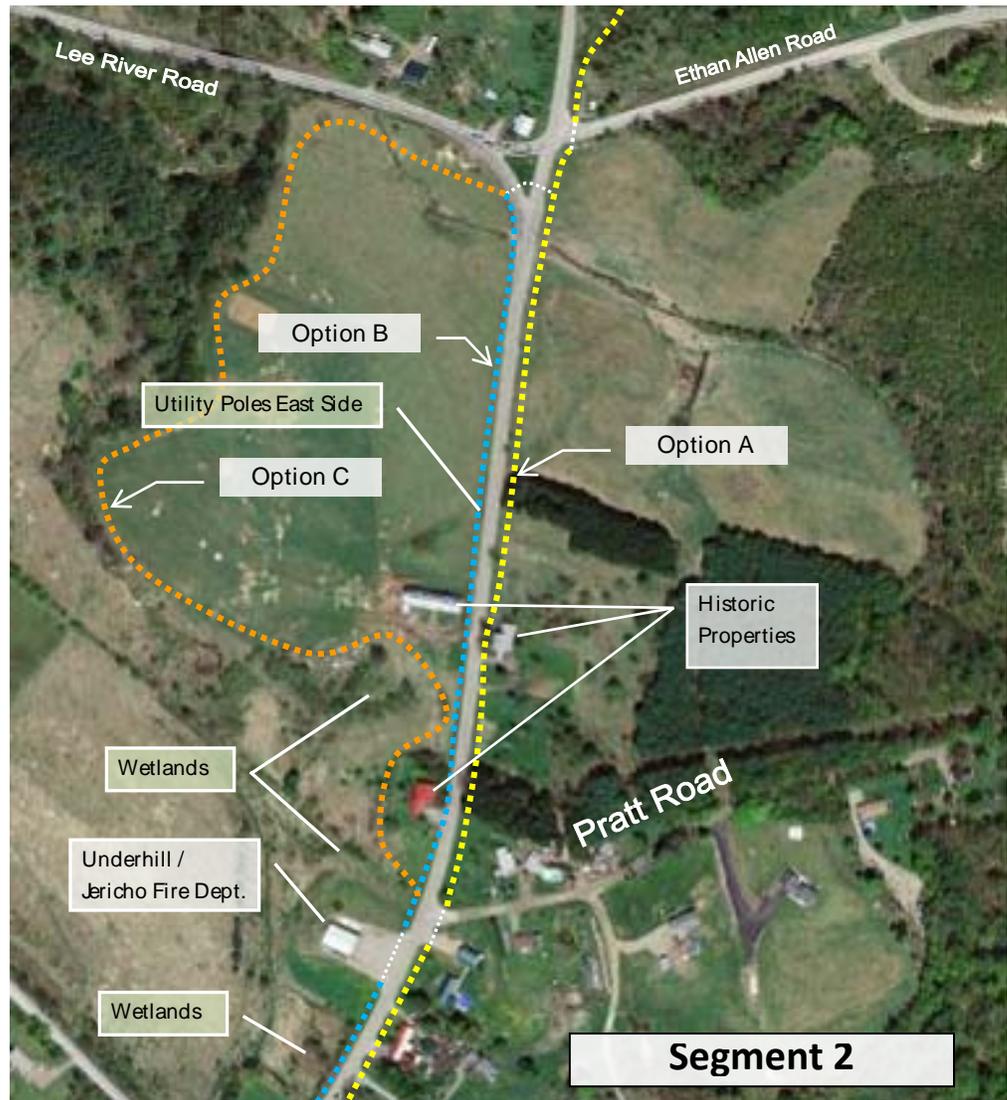
Segment 2 – Ethan Allen Road to Pratt Road

There are three alignment options presented for this segment. They are discussed as follows.

Option A is the most direct alignment up the hill to Pratt Road. This option would roughly parallel the east side of Browns Trace Road, separated from the road by a vegetated buffer of at least three feet, and more where possible. It would therefore be constructed partially within and partially outside the reported three rod right-of-way.

The Option B alignment is similar to Option A except the path will follow the west side of Browns Trace Road instead. To do this it must first cross Browns Trace Road and the slip ramp from Lee River Road onto Browns Trace Road. There are obvious safety concerns with crossing the slip ramp since it is a free right movement. The VTrans road safety audit suggested reconfiguring the intersection to a more conventional 90 degree intersection where Lee River Road would be stop sign controlled. That change would improve the multimodal path crossing. If the intersection is not reconfigured it may be necessary to install pedestrian actuated crossing lights or warning flashers on the slip ramp. Another option would be to install a speed table on the slip ramp at the path crossing. This would slow vehicles down at all times.

The Option C alignment entirely avoids the historic properties by taking a cross country route out behind the properties. The property is owned by the Underhill / Jericho Fire Department. The option would be dependent on obtaining their permission to cross the property. The property is currently in agricultural use, however the Fire Department is concerned over the negative impacts that the path could have on their ability to sell or develop the property. The path alignment that is depicted in the above Segment 2 figure follows the outskirts of the pastures, but it could be routed differently to appease the Fire Department.

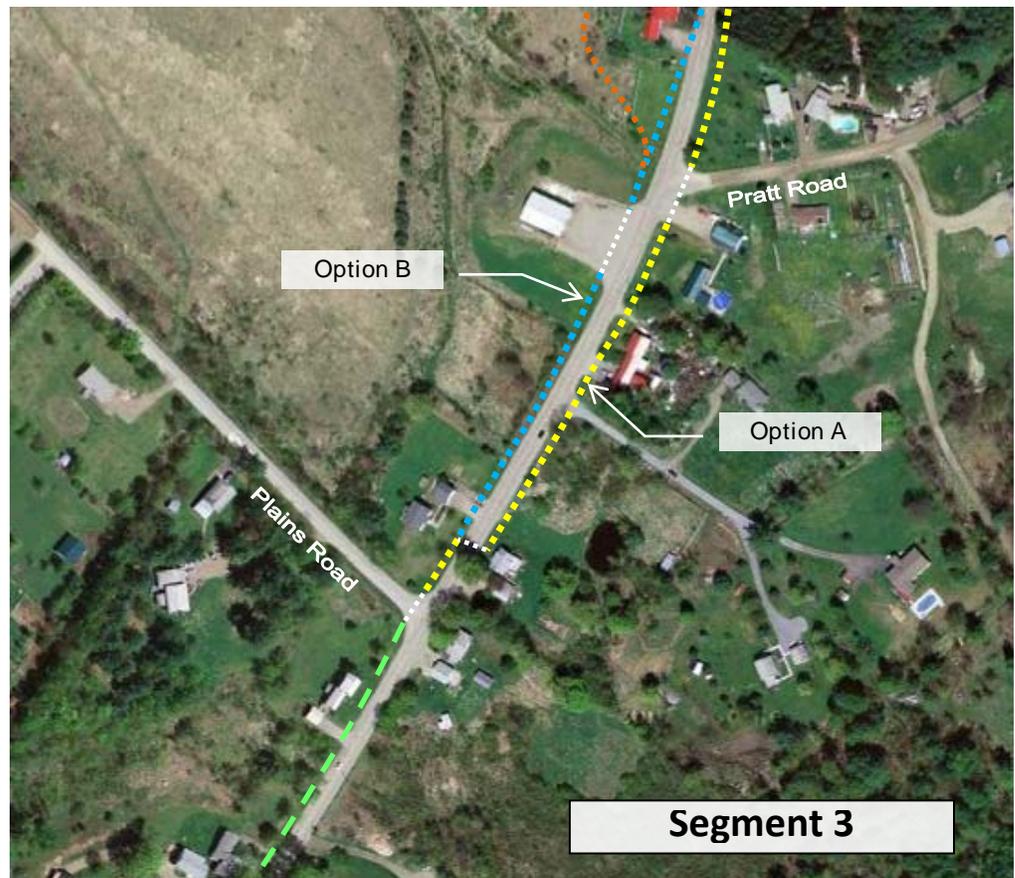
Segment 3 – Pratt Road to Plains Road

There are two shared use path options for this segment. The selection will be driven by which side of the road the path is on under Segment 2.

Option A passes in front of two residences, one of which is very close to the road. Option B crosses the wide Fire Department driveway and passes by one residence. Option B is somewhat constrained by wetlands that extend close to the road. To minimize impacts the path may need to be supported by a low retaining wall, and the width would be reduced to 8 feet in that area.

Option A is shown crossing Browns Trace Road just prior to Plains Road. The sight lines are good at that location and the crossing would be out of the Plains Road intersection area. The goal is to move the path to the west side by Plains Road since the east side becomes very difficult south of Plains Road.

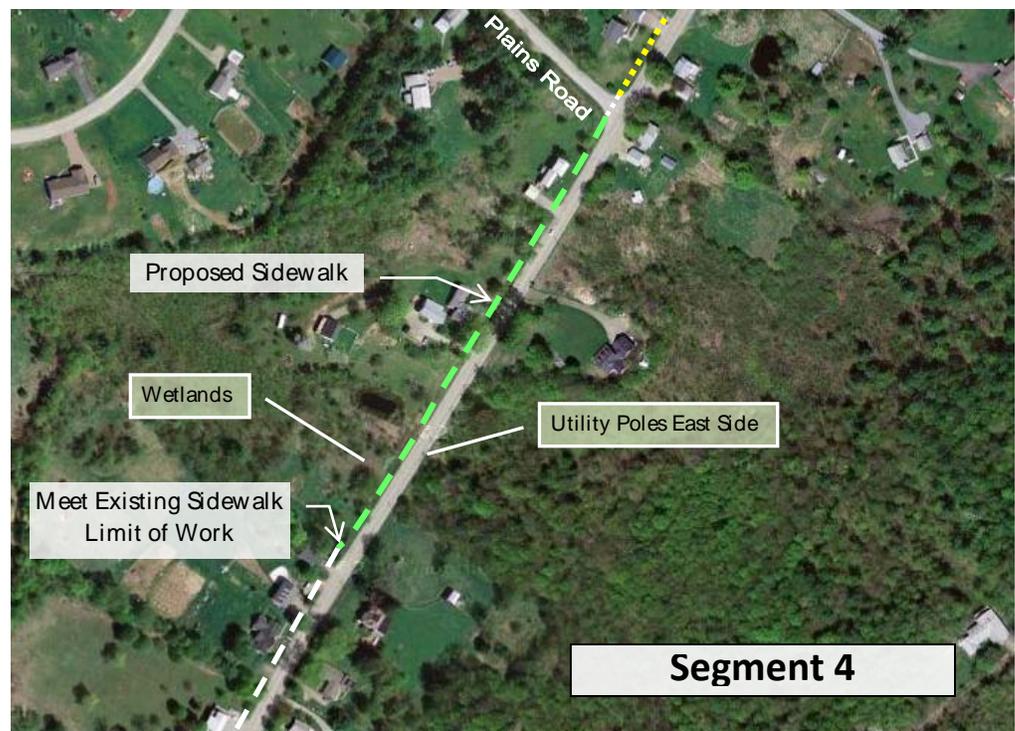
Segment 4 – Plains Road to the Existing Sidewalk in Town Center

Segment 4 is very constrained on both sides by utility poles, wetlands and residences. The recommended solution in this segment is to extend the existing concrete sidewalk along the west side to Plains Road. This will provide a pedestrian connection to the residents of Plains Road as well as to the shared use path that reaches all the way to the MMU High School.
