**Environmental Assessment For
the Village of Underhill**

Flats/Riverside

Towns Of Underhill And Jericho,
Vermont

Stone Project # 051570-W

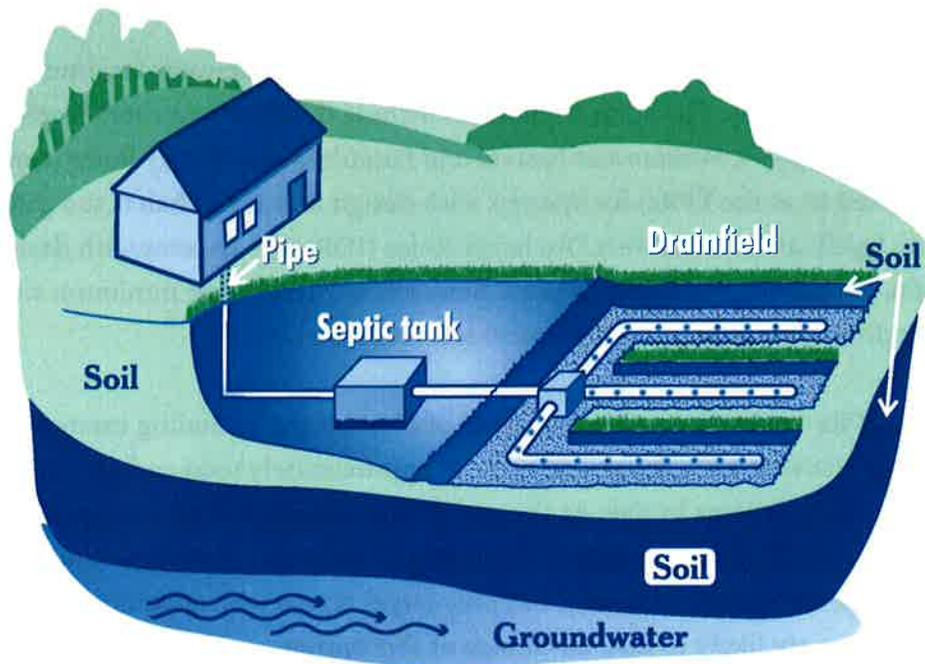
Figure 3: A typical individual onsite septic system. Source: US EPA.

The traditional onsite septic system in the Underhill Flats/Riverside Village (and throughout Vermont) includes a 1,000 gallon concrete septic tank, a concrete distribution box, and leach bed or trenches (Figure 3). The septic tank settles out the solids and provides some treatment; the distribution box splits the flows evenly between pipes or trenches, and the leach bed or trenches (made out of stone or alternative materials) with perforated pipe covered with filter fabric or hay, along with the unsaturated soils below the system provide the final distribution and treatment. Pump stations can be added after the septic tank where the disposal field is higher in elevation than the building outlet, or for at-grade, mounds, and advanced treatment systems. Pressurizing the disposal field also allows for greatly improved distribution of the effluent, making more efficient use of the entire field.

Effluent filters and risers are now included in the septic tank. The effluent filter is located at the tank outlet, and screens any solids from the effluent when it leaves the tank. If the tank is not pumped regularly and becomes full of solids, the filter will plug and the system will slow or back up before the solids leave the tank and enter the disposal field, where the entire field may need replacing. The filters need to be hosed off usually once a year, which is also when the septic tank should be inspected. Risers over the accesses to the tank allow for easy access for maintenance.

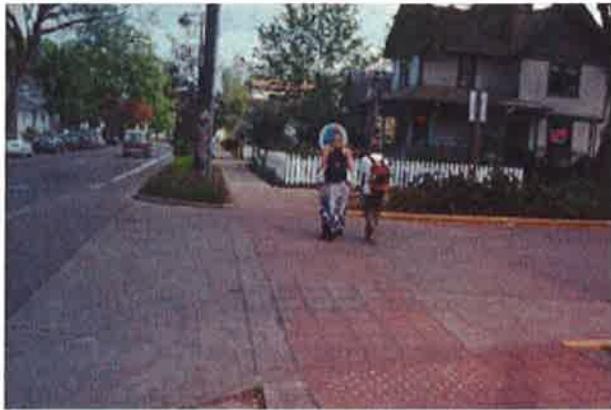
Speeds throughout the study area appear to be quite high as compared to the posted speed limits. While the village enjoys a higher density of buildings that should act as a visual sign to drivers to slow down, it is not enough. Other infrastructure, such as sidewalks, gateways, and

storefronts are missing to add to the information a driver uses to decide whether to slow down in the absence of police patrols.

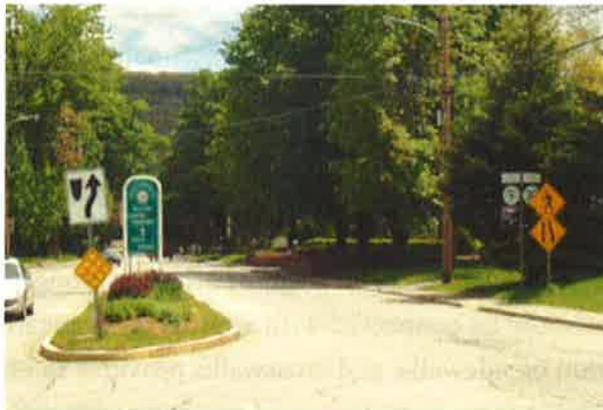
Gateways are constructed at natural entrance points to the village.

Whether signs, banners, lighting, textured pavement, or some combination of all of these, gateways tell the driver “You are now in a different place – it’s time to slow down”. A gateway won’t work if it is too far out of the village. It

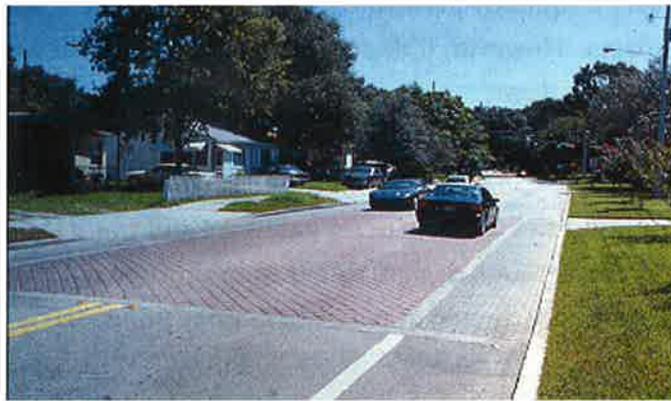
Traffic calming devices can be rather innocuous or rather severe. Simple techniques such as changing the pavement texture occasionally, perhaps for a cross walk, or creating a speed hump that rises and falls 4 - 6 inches over 20 - 30 feet can easily keep drivers' attention and force speeds to slow. More severe approaches such as chicanes where the road begins to weave within the right of way seem out of place in Underhill Villages existing road network, though such strategies may fit in nicely with future development plans at Green Crow Lumber or other sites.
